SAFETY ALERT NOTICE.

Drug / Product / Device:
Tail lift – Step edge safety strip – 3-way Stop.

Issued by: NAS Quality & Safety Team / NAS Fleet Department.

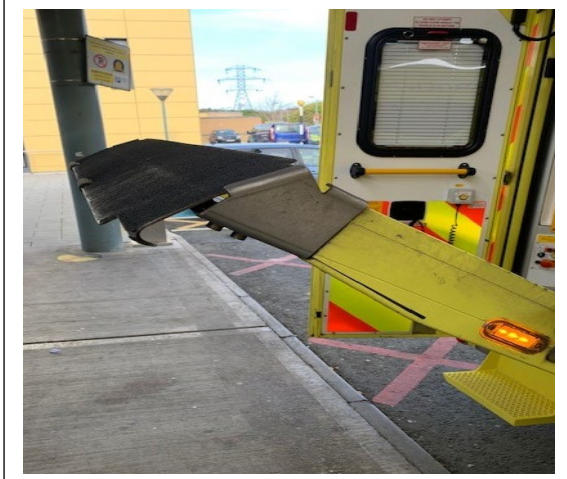
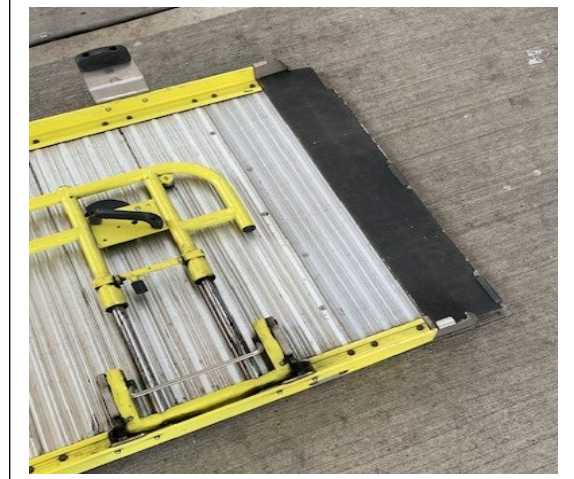
The tail lift safety edge strip (3-way stop) is intended to self-position when the tail-lift is operated and thus prevent a stretcher from unintentionally rolling off the ramp in conjunction with the trapdoor system.

It appears that in some rare instances the mechanism of this safety device can become jammed with dirt and dust from the roads. This is probably as a result of the ramp not being fully washed which would dislodge the dirt.

Please check the function of this strip every time the tail lift is used and before a stretcher/person is allowed on to the lift. Person operating the ramp controls, to ensure the stop strip, is at the correct angle, before allowing stretcher/chair/people onto ramp.

Please ensure that when vehicles are being washed with a manual lance (**not drive through rollers**) that the ramp is lowered sufficiently to 90° and wash the area around the 3-way stop top and bottom. Please be careful that this activity is supervised at all times as people may not expect a ramp to be deployed in this way.

If the only wash available is a drive through wash then it may be necessary to ensure that the strip area is separately washed with hot soapy water and function checked.

Please ensure any defects are noted, reported & repaired.
