## SAFETY ALERT NOTICE.

Drug / Product / Device : Baxter ONE-LINK IV Connector

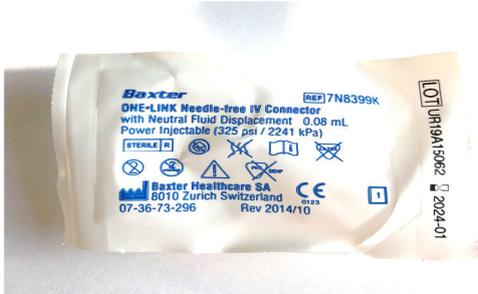
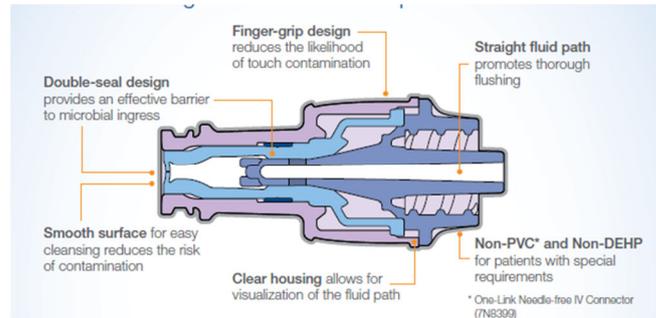
**Identified Issue / Concern / Problem/ Evidence of harm.** The Baxter ONE-LINK IV connector has been introduced to replace the Baxter Clearlink Connector. A number of reports have been received of difficulty in flushing and sub-optimal flow rates of IV fluids when in use.

It is imperative in use that the ONE-LINK connector is fully tightened onto the catheter hub, this may take a little more force than one anticipated and the catheter should be stabilised using the wings and port to avoid vascular or skin damage. This tightness is a design feature as the connector is approved for use with pressure devices up to 325psi and syringe drivers. Fully tightening the connector onto the hub resolves the reported flow rate issues.
