## SAFETY ALERT NOTICE.

### Buccolam (midazolam) prefilled syringes – all formulations.

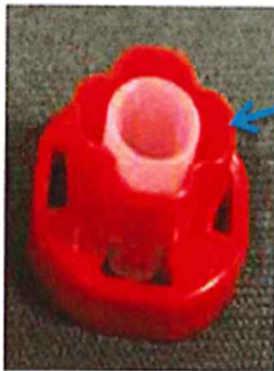
In a small number of cases, the translucent tip-cap has remained on the syringe tip when pulling the red cap off.

If the translucent tip cap remains on the syringe tip there is a risk of this detaching into the patients mouth and being inhaled or ingested.

Translucent tip-cap

When administering BUCCOLAM, check that translucent cap has been removed with red cap.

If the cap has not been removed, remove it manually.
