SAFETY ALERT NOTICE.

Drug / Product / Device : FERNO Compact Chair.

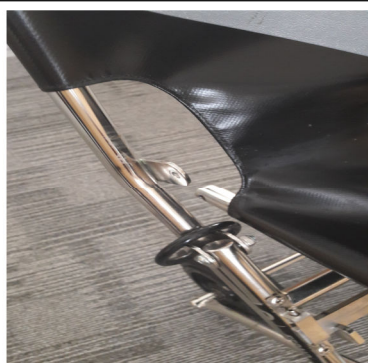
On the 21st of February 2018 the seat in a ferno compact chair dropped as a bolt had become loose, this led to staff injury. Today 5th April a further chair seat fell apart after the same bolt loosened and fell out.

Missing Bolt & Nut

Please inspect all Ferno Compact Chairs on all vehicles and including those which are in storage.

If any bolts are found to be loose or any other defects are noted, please arrange repair and withdraw from service in conjunction with supervisor and line manager. Please complete a defect form and a NIRF03 for any faults discovered.

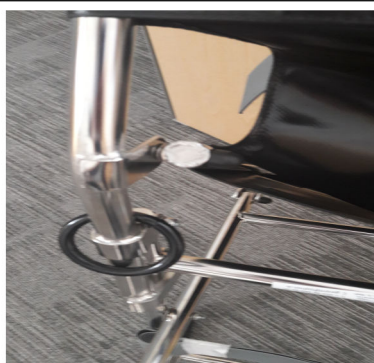
An identical nut and bolt on the opposite side of the seat were found to be so loose as to be just about to separate.

Bolt on opposite side loose

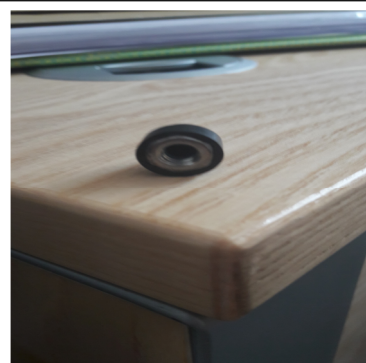
Nylock Nut which fell off
